Bf 109 E-3, Yellow 37

Bf 109 E-3, Yellow 39

Bf 109 E-3, Yellow 9

Romanian Messerschmitt Bf 109E camouflage and markings

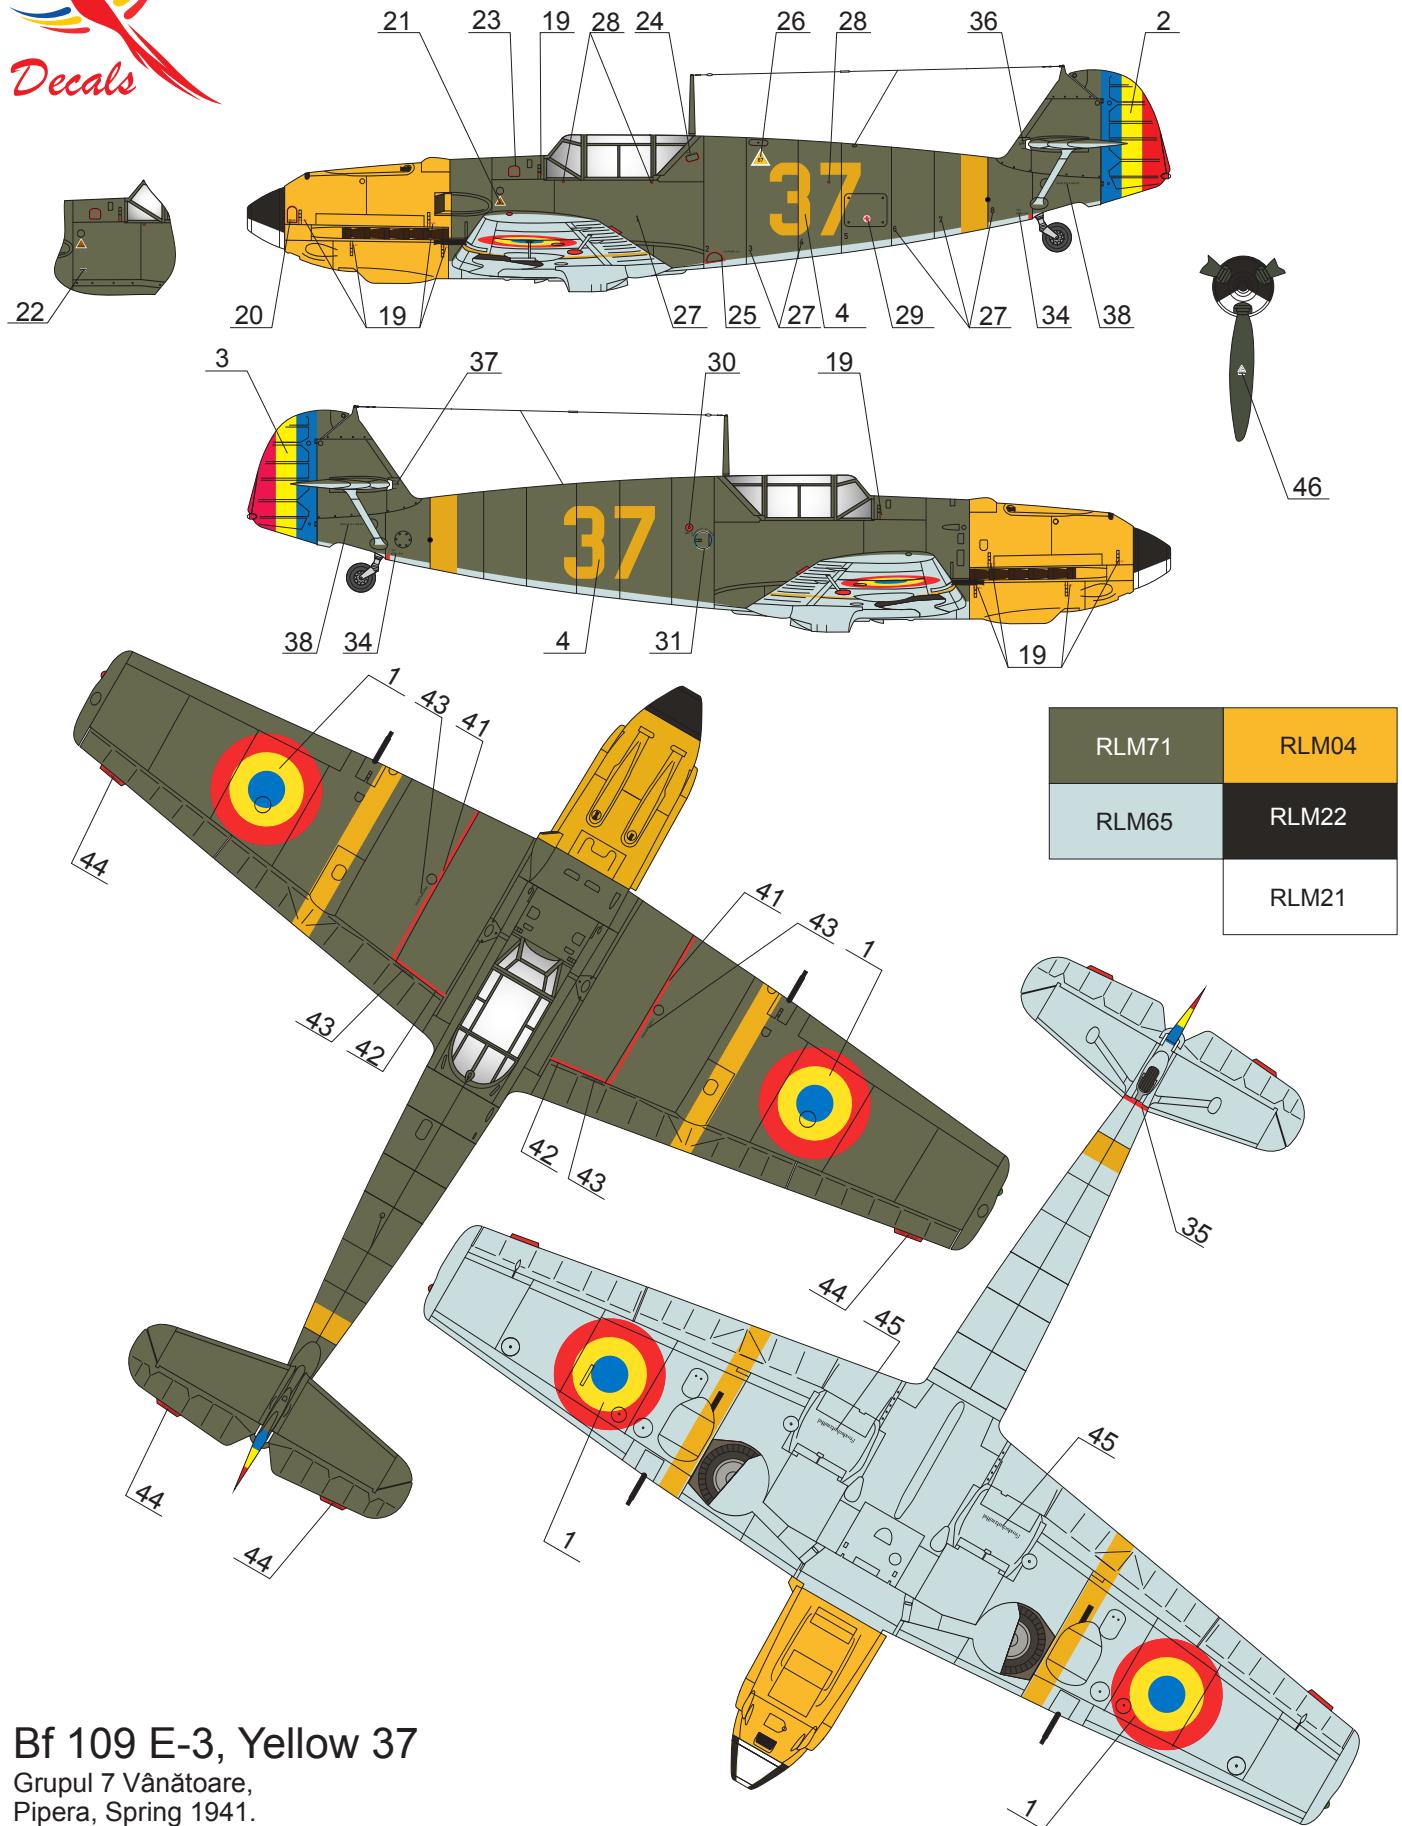
Grupul 7 Vânătoare,
Pipera, Spring 1941.

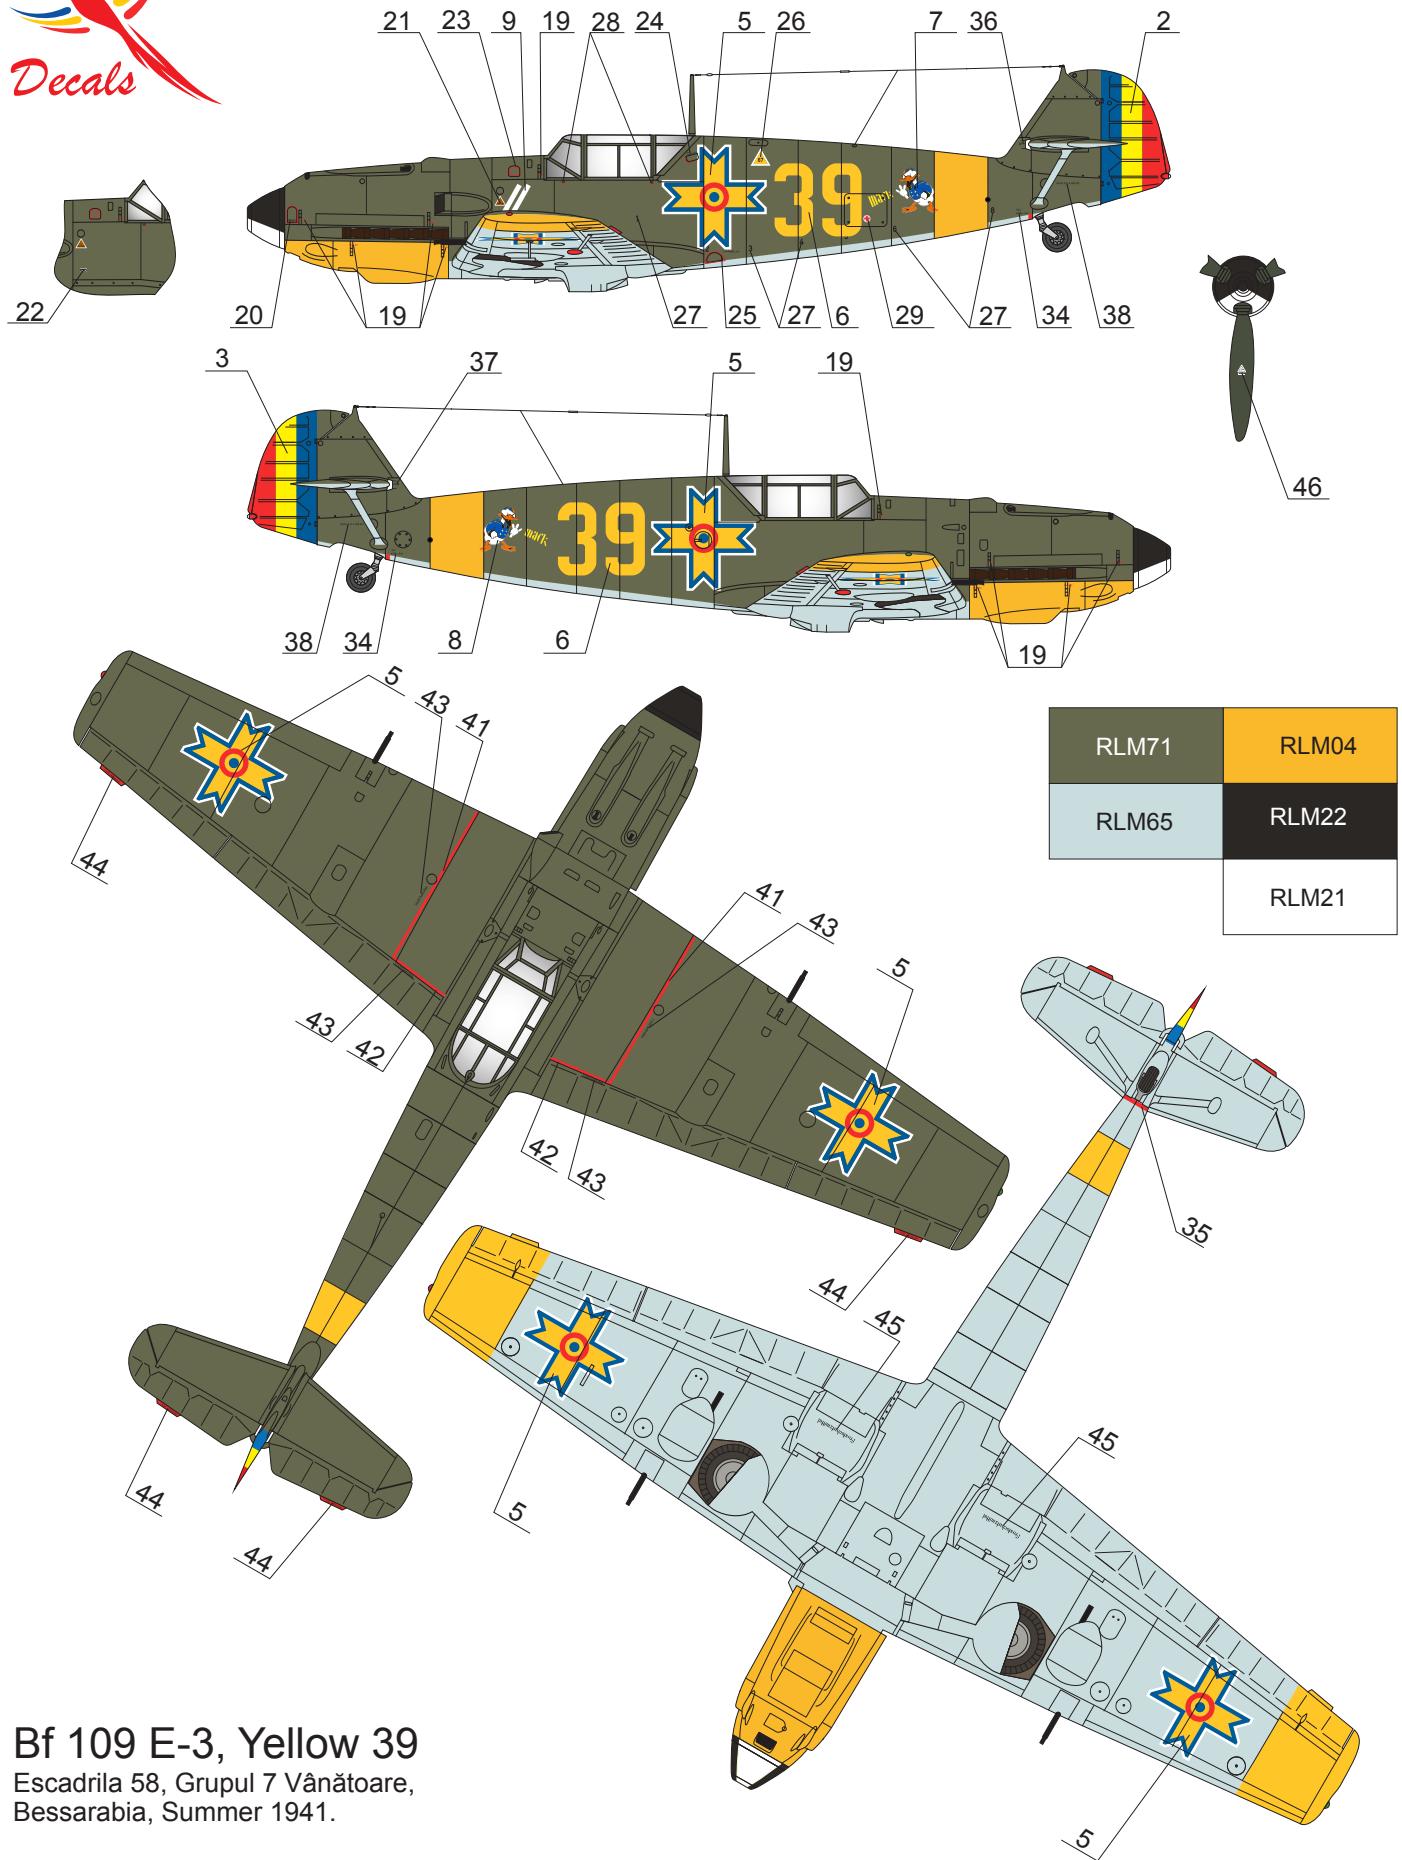
Escadrila 58, Grupul 7 Vântăoare, Bessarabia, Summer 1941.

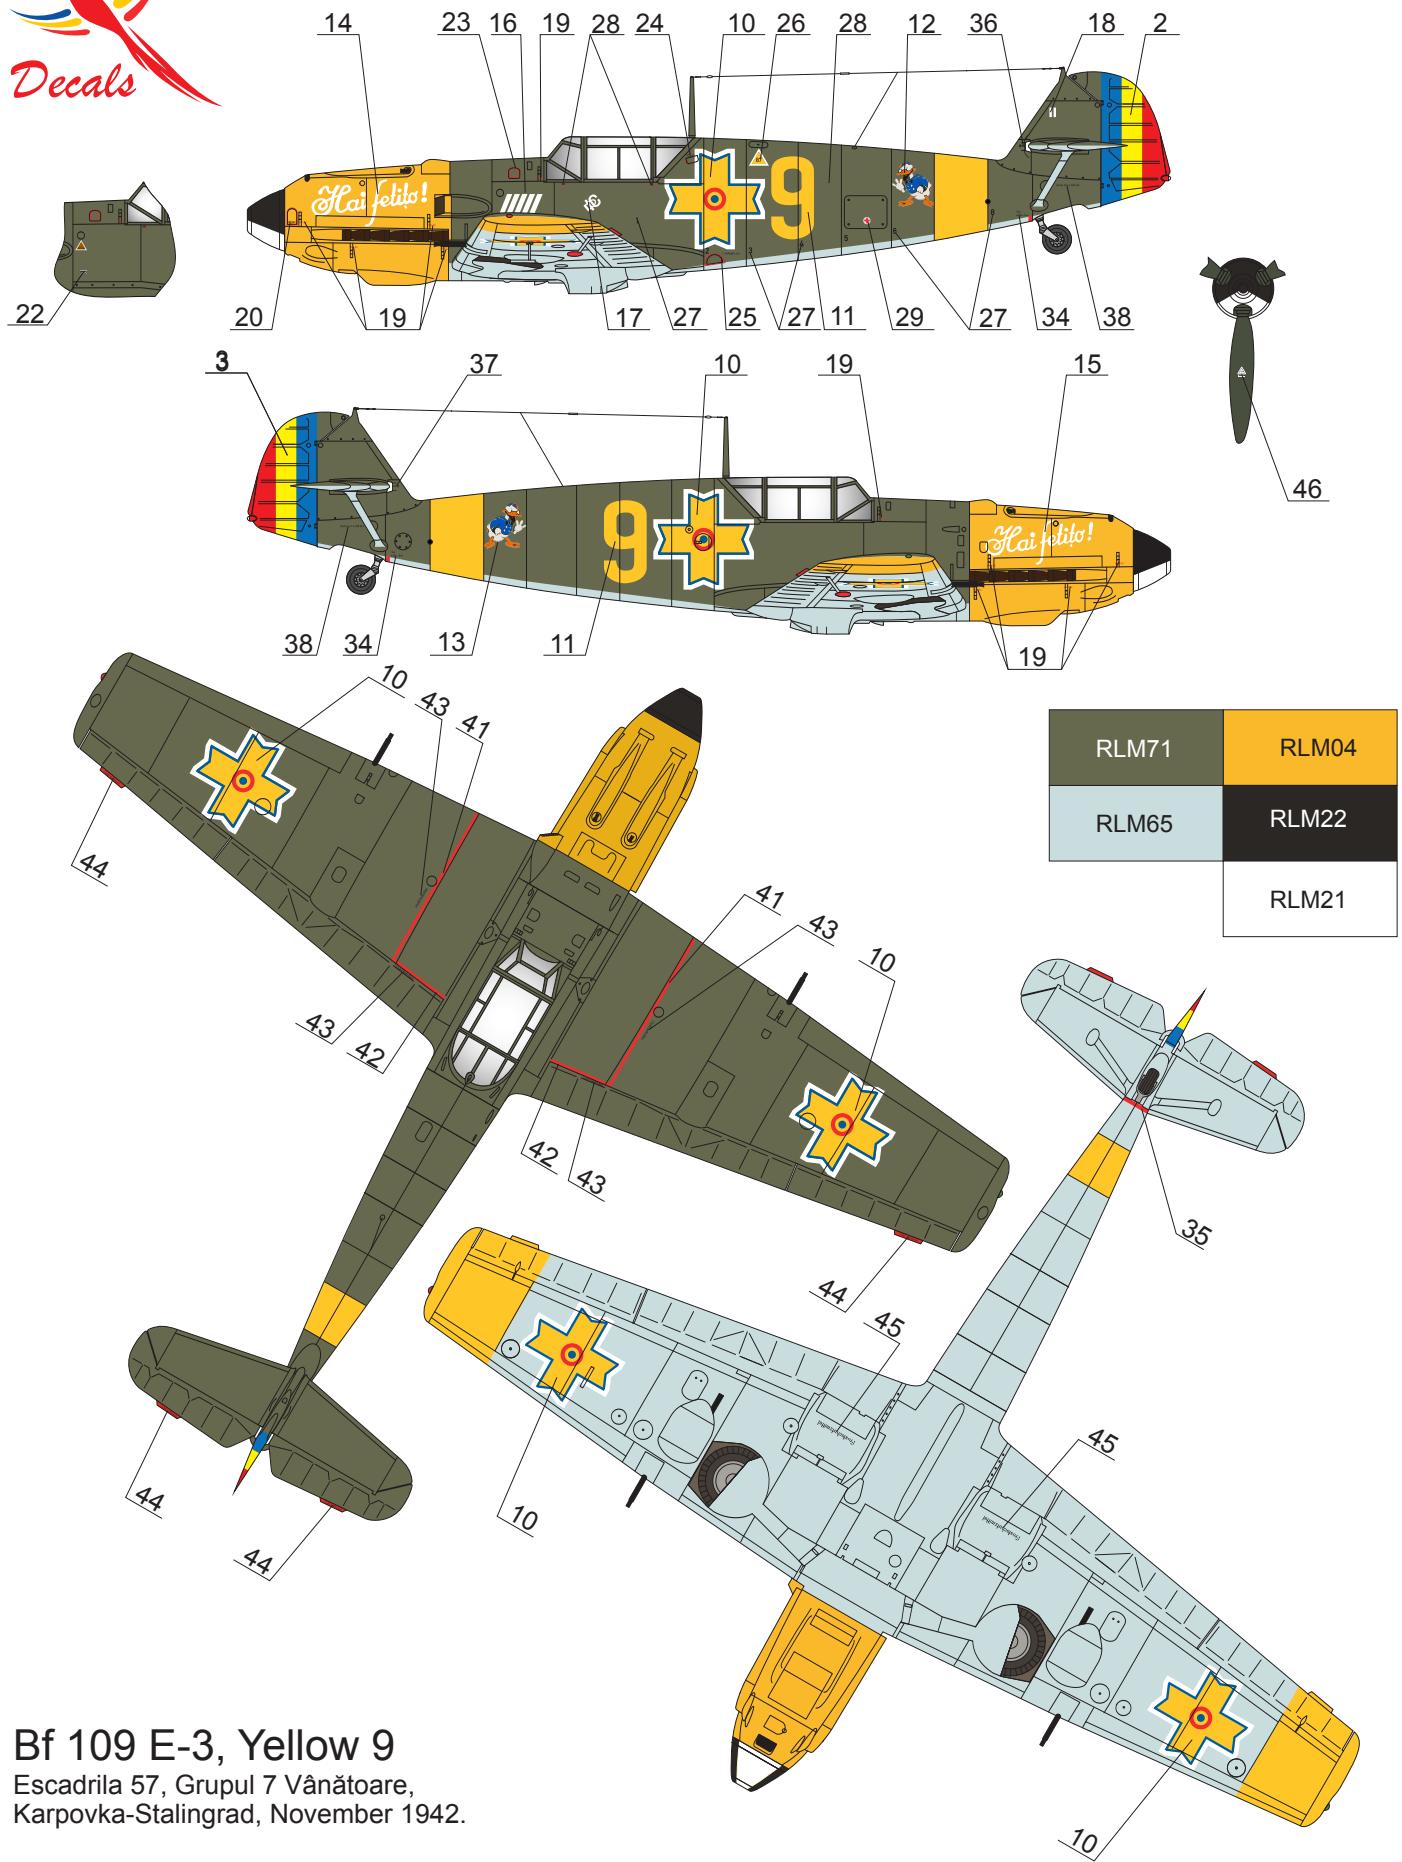
Escadrila 57, Grupul 7 Vântătoare,
Karpovka-Stalingrad, November 1942.
